Door Lock Replacement

Door Lock

RV Lock Keyless Entry Door Lock Latch Handle for Trailer Caravan Camp with Remote Controller (RV Lock)

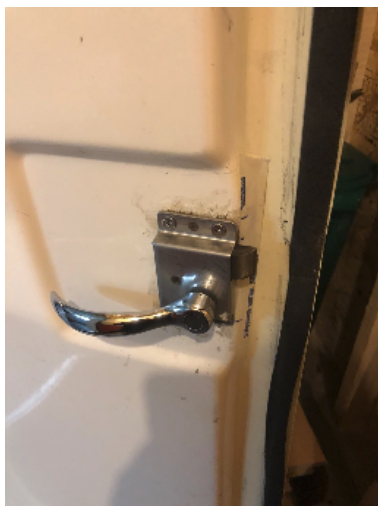
Mark the position of the current lock.

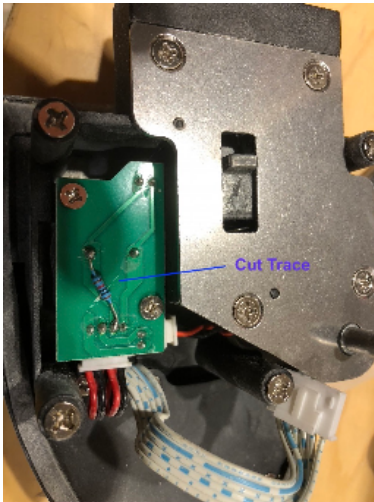
Reduced Buzzer Volume

The buzzer sound out of the box is pretty loud. To fix, I cut the copper trace and jumpered the connection with a 10K resistor to reduce the volume.
