# Door Lock Replacement

## Door Lock

RV Lock Keyless Entry Door Lock Latch Handle for Trailer Caravan Camp with Remote Controller (RV Lock)

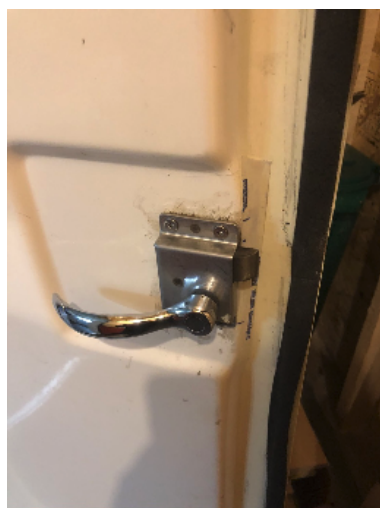
Mark the position of the current lock.

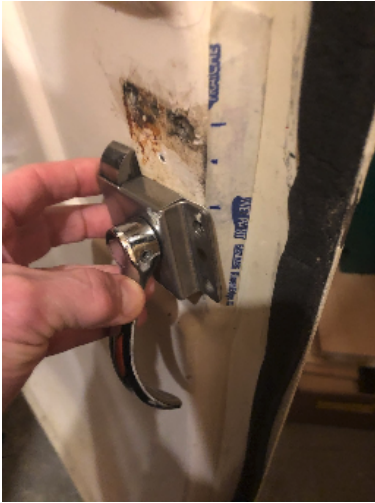
Remove the lock

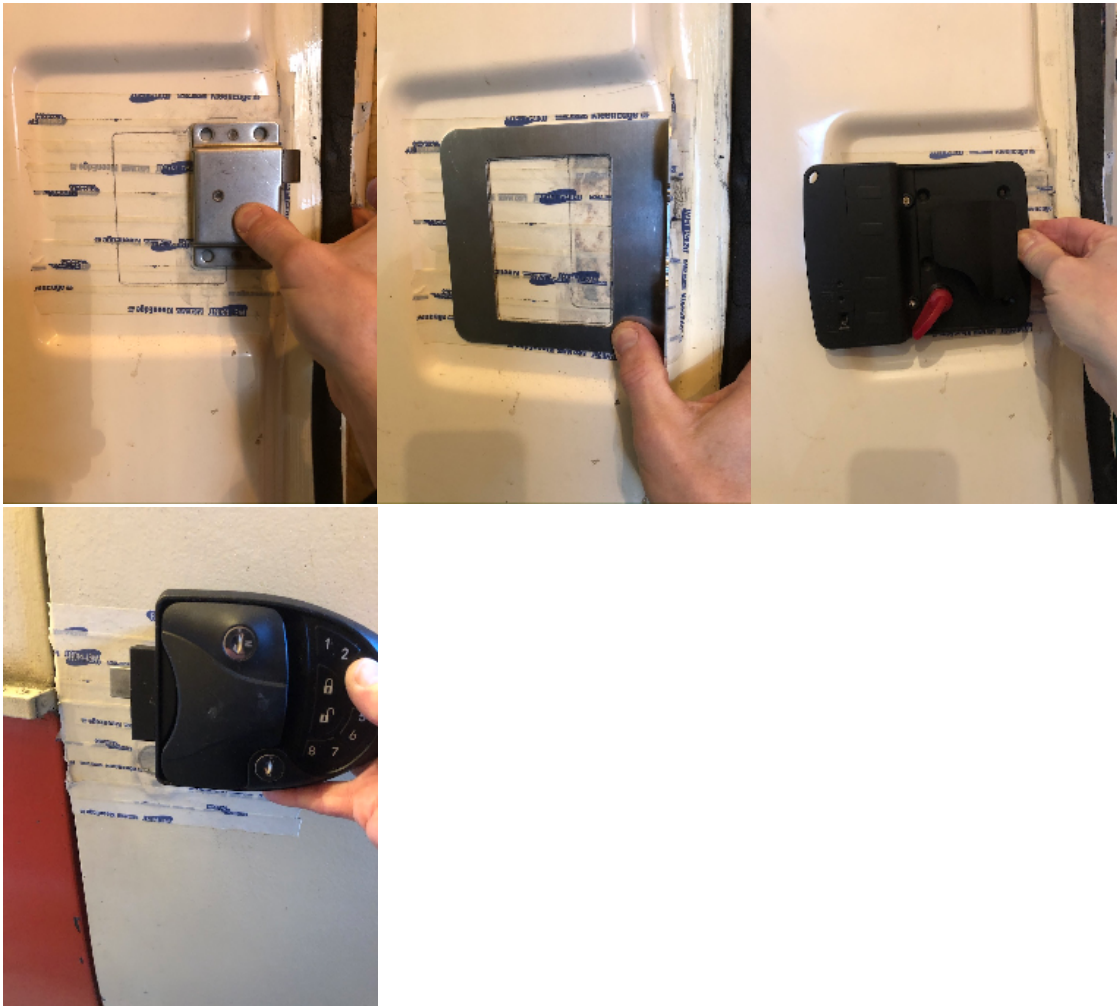
Mark location of new lock. I dropped the lock location down slightly so that the lock sits in the middle of the door depression.

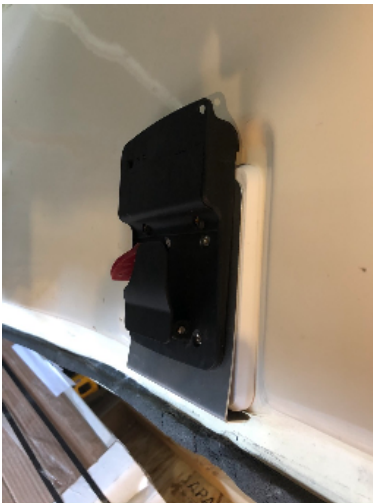
The inside plate doesn't sit perfectly against the beveled curved of the door near the latch.

The inside handle seems a bit wobbly. Will need strengthen the door around the door lock hole such that it doesn't bend in when tightened.

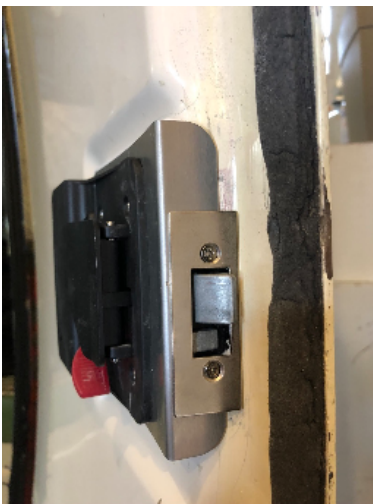
The plate that goes around the latch does not sit nicely and prevents proper closure. Currently this has been removed.

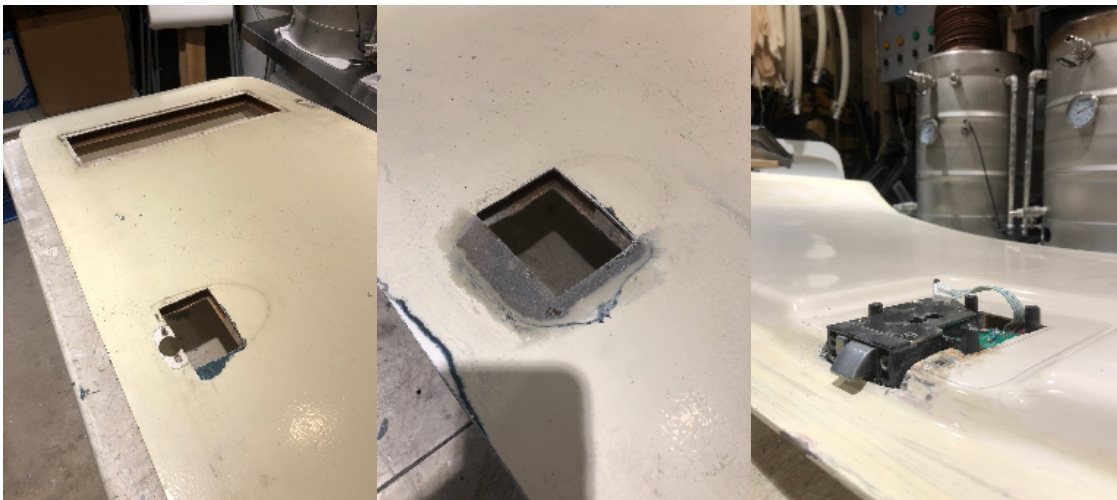
In order to have a nicer looking lock installation, I removed the door and fiberglassed the hole on the front of the door and added fiberglass to the inside to make the lock sit flush.

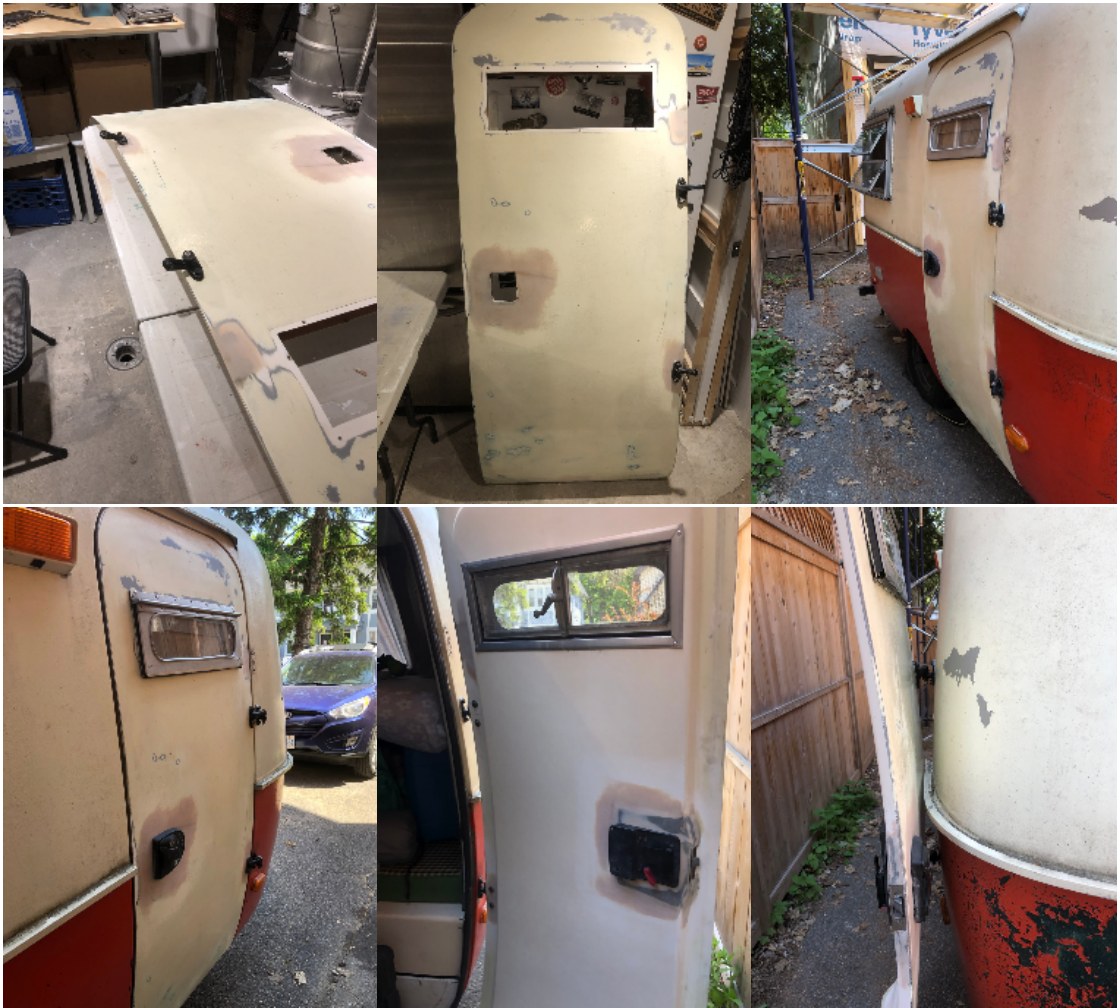
In order to get the hinges not to hit the belly band, I moved the hinges to  $\frac{1}{3}$  the height of the door.

The door measured  $64 \frac{1}{2}$ " which put the hinges at  $21 \frac{1}{2}$ " and 43".
