Hot Water Tank

High Temp Thermo Cut-Off

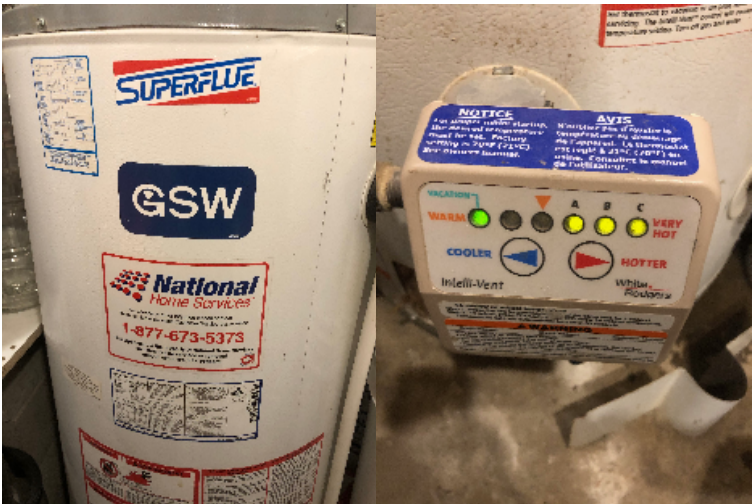
Specification	Details
Make	GSW
Model	8G50NVH-ES-02
Capacity	50 US Gal
Recup per/hour	34.5 US Gal

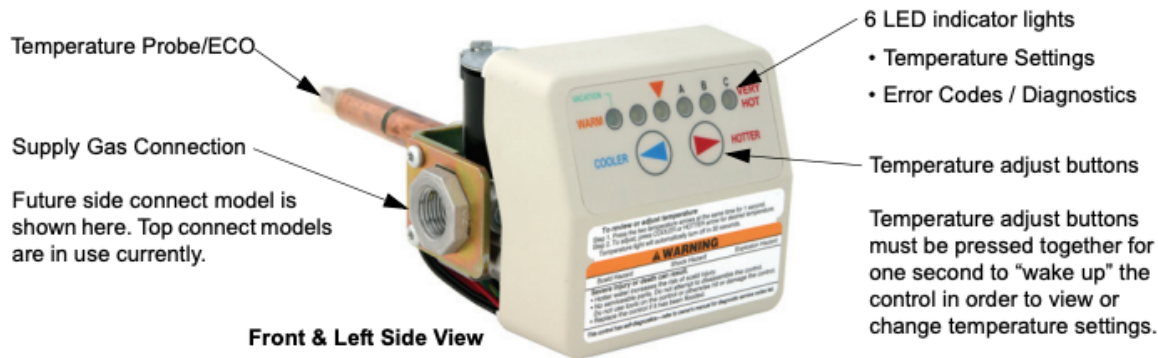
INTELLI-VENT™ CONSTRUCTION

INTELLI-VENT™ CONTROL SPECIFICATIONS	
Body	½ inch NPT inlet. ½ inch inverted flare outlet. (RH thread natural, LH thread propane)
Electrical Ratings	120 VAC, 60 Hz, 1Ø, 5-7 FLA. Ignitor load: 2 amps maximum. Blower/inducer motors: 3 amps full load - 4 amps locked rotor.
Max Inlet Gas Pressure	½ PSI maximum (14.0" W.C.)
Temperature Range	70 - 160°F Residential. 120 - 180°F Commercial.
High Temp Cut Off - ECO	195°F Residential - single use (control must be replaced) 195°F Commercial - resettable (reset temp 120°F)

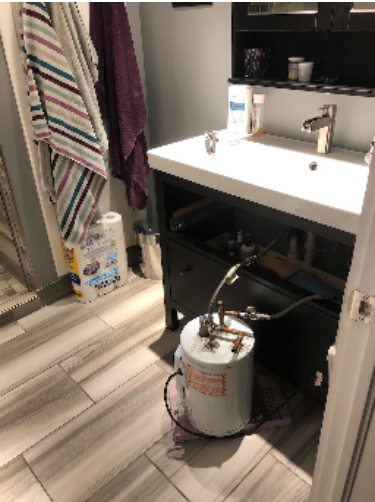
Picked up 10L electric water heater and connected it to the hot and cold line near the shower. Allows for a quick shower when desperate.

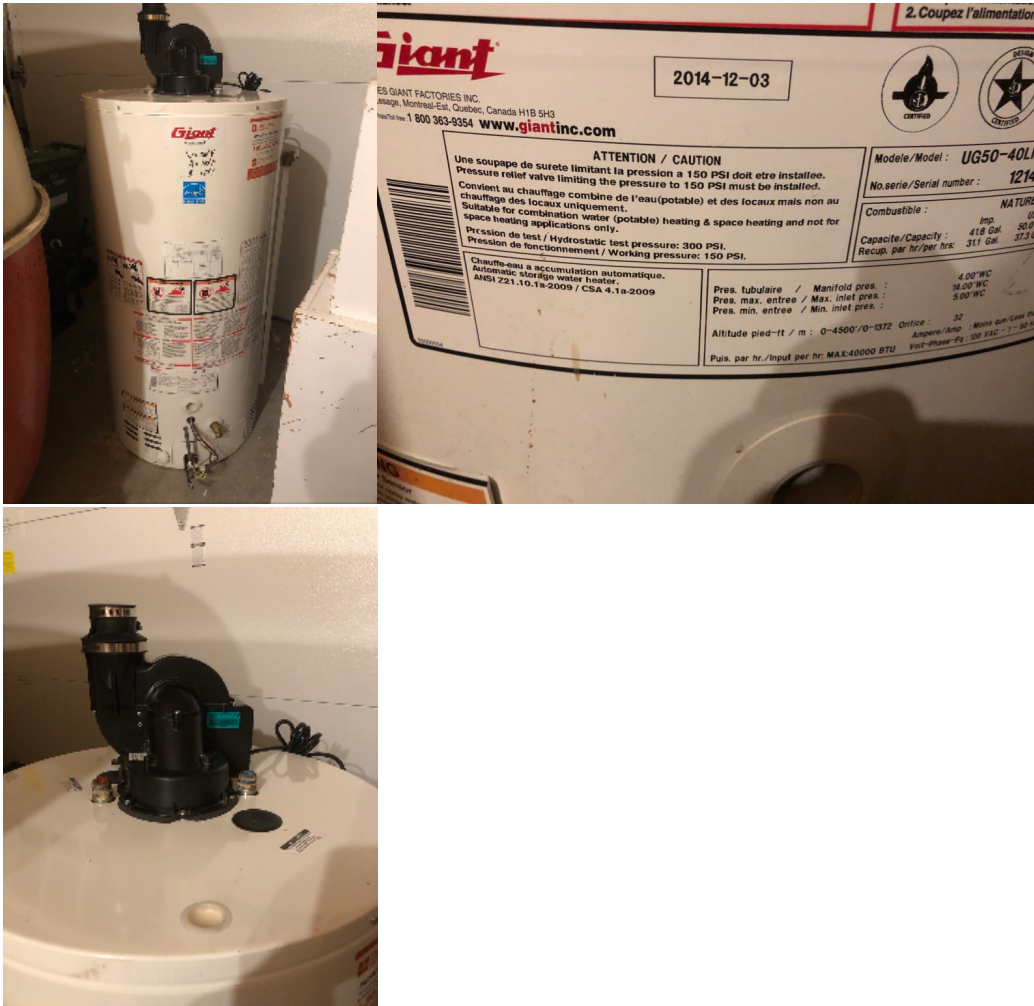
Specification	Details
Make	Giant
Model	UG50-40LFPV1-N2U-DE
Capacity	50 US Gal
Recup per/hour	37.3 US Gal
User Manual	GI-IM052En-Res-Gas-PV2.pdf
