Karcher Pressure Washer

Overview

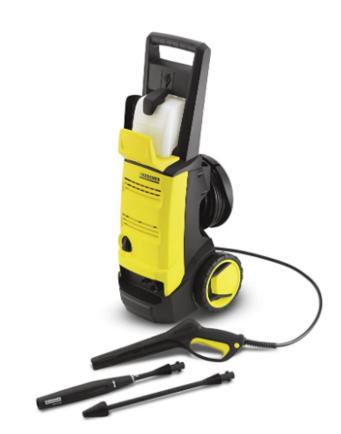
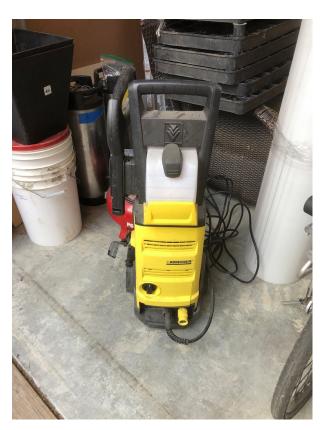
Make	Karcher
Model	K 5.65 QC
PSI	2000 PSI
Water Volume	1.4 GPM
High Pressure Hose	25 ft.
Unit Weight (with out accessories)	32 pounds
Unit Dimensions	13.5" x 13.8" x 34.3"
Child Safetly Lock	
Onboard Removable Detergent Tank	
Induction Motor

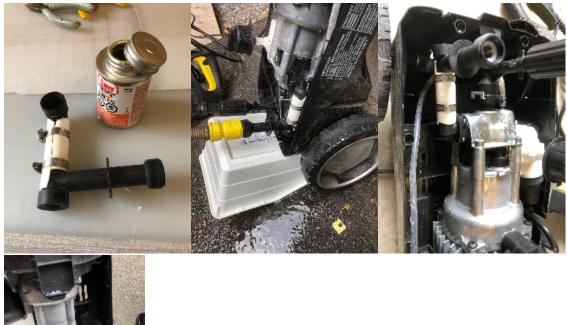
After disassembling the unit, I discovered that the water inlet was leaking at the seam of the pipe.

An attempt was made to repair by gluing on some pex pipe to the outside and clamping. This helped but did not fix 100%.

If I had used the right type of glue/pipe I might have had better luck.

So, I decided to order the part online (\$20) for a total of \$40 including taxes and shipping.
