# Hot Water Tank

## Overview

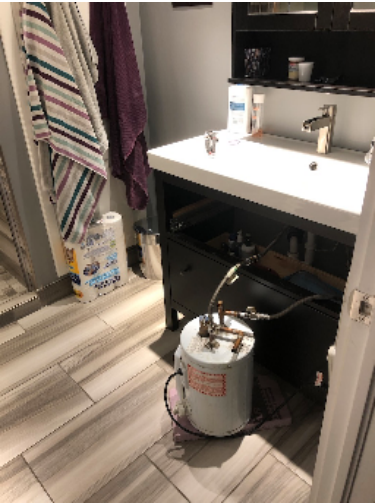
**Temporary Fix**

Picked up 10L electric water heater and connected it to the hot and cold line near the shower. Allows for a quick shower when desperate.
